Invoice

RED RHINO®

Issued: 11/30/2021 Due: 11/30/2021 Invoice: #238464

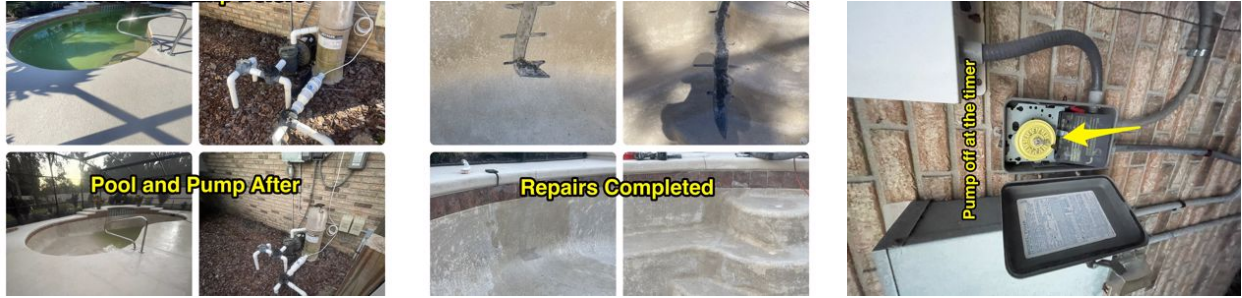
Repair completed. Water level is half empty Pool can be filled immediately Pump is off at the timer Valves were readjusted to their original positions

- Check underground water tables
- Drain water enough to perform repair
- Repair crack with staple(s)
- Patch surface (see patch disclaimer for details)
- 1 year warranty included
