Invoice

RED RHINO®

Issued: 11/30/2021 Due: 11/30/2021 Invoice: #238464

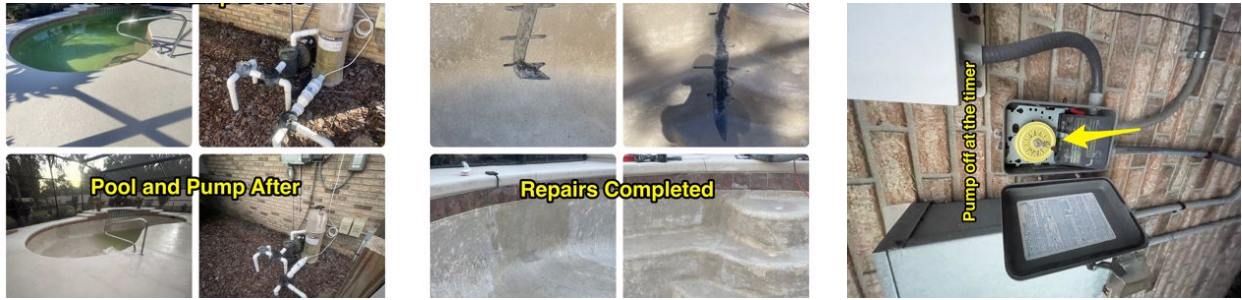
Repair completed. Water level is half empty Pool can be filled immediately Pump is off at the timer Valves were readjusted to their original positions

DESCRIPTION OF WORK	QUANTITY	PRICE	TOTAL
Staple Crack (3-5 feet)	1	\$1,495.00	\$1,495.00

- Check underground water tables
- Drain water enough to perform repair
- Repair crack with staple(s)
- Patch surface (see patch disclaimer for details)
- 1 year warranty included
