## Results & Findings

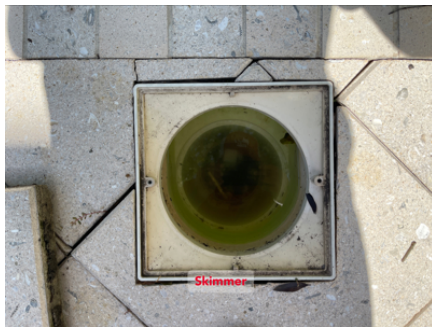
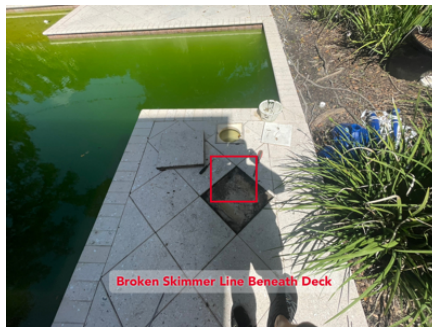
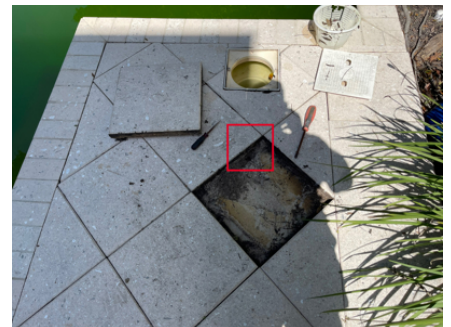
Found broken skimmer line under the deck. Marked deck with photo. Needs to be repaired. Plugged off skimmer pipe and shut off at valve to prevent further water loss.

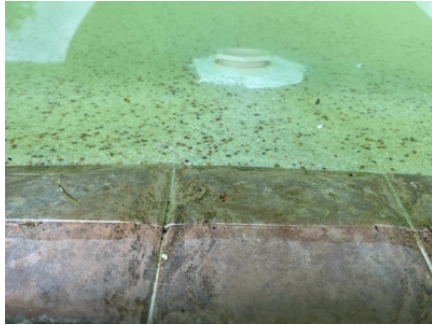
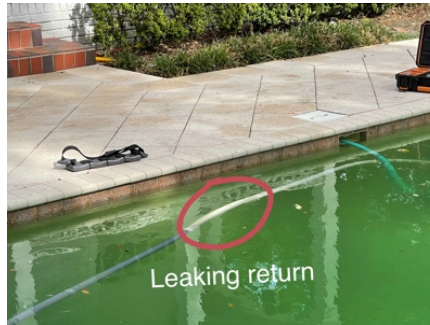
Found leak around pool return. Patched with epoxy. Recommend proper repair.

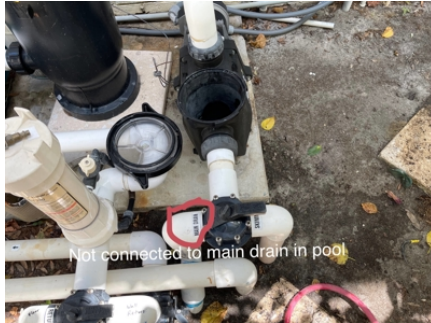
Pipe labeled main drain on pool pump may actually be a waste line. Didn't purge air into pool.
