## Results & Findings

📅 Wednesday, September 29, 2021 appointment

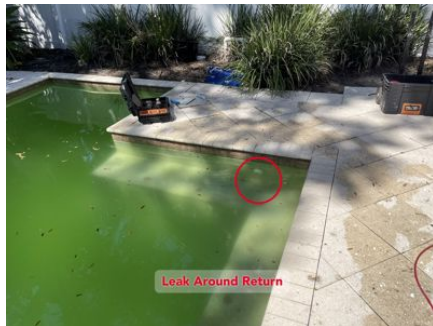
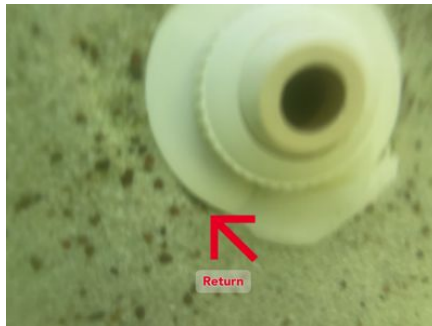
Found leak around pool return. Patched with epoxy. Recommend proper repair.

Epoxy was applied as a temporary patch to the leaking skimmer throat and pool return so that it can be ensured all leaks have been identified and all appropriate repairs have been quoted.

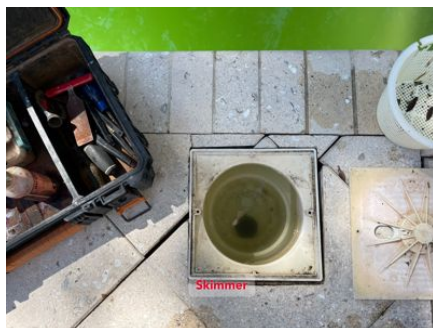
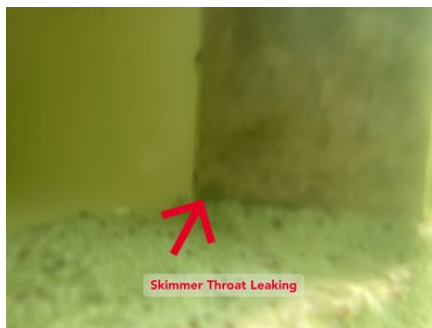
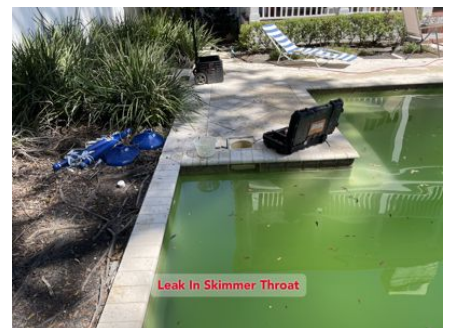
Found leak in skimmer throat where the plastic skimmer butts up to the cement pool shell. Patched with epoxy. Recommend proper repair.

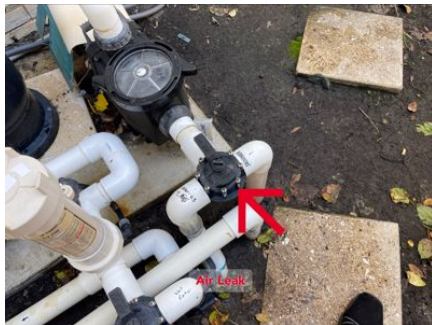
Found air leak at valve. When pump is running, air is entering through the skimmer Jandy valve needs to be serviced. See picture for dysfunctional valve.

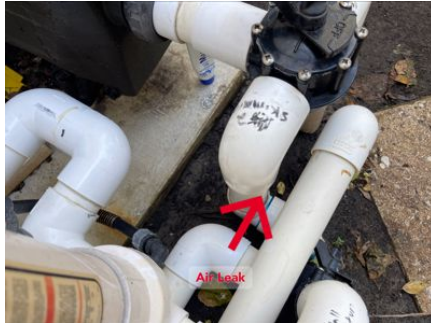
Found air leak at suction side elbow. When pump is running, air is entering the system through elbow. Fittings need to be replaced. See picture for dysfunctional fitting.

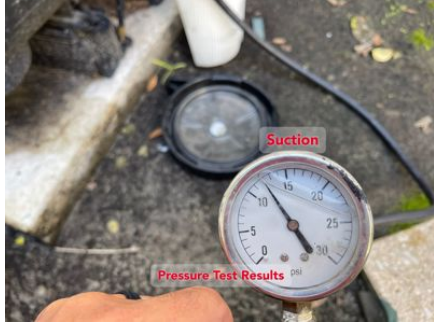
Pressure tested all lines. All lines appear to be holding solid.
