Invoice

Results & Findings

Leaks

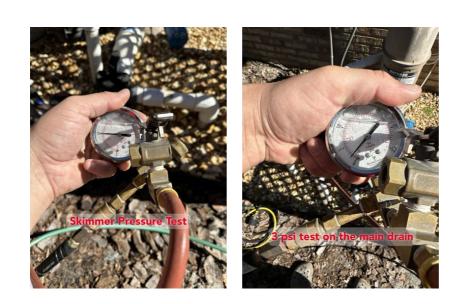
Tested Popups -- Passed Additional Notes:

Specialist induced all other plumbing

The pool will continue to leak until repairs are completed.
