Invoice

Results & Findings

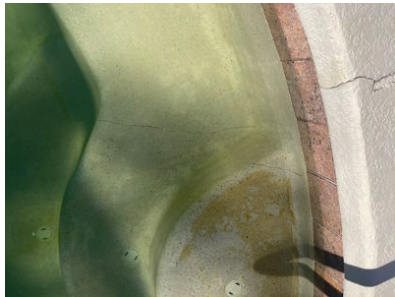
Found broken pop up line directly underneath pop up. Needs to be repaired.
