Invoice

Results & Findings

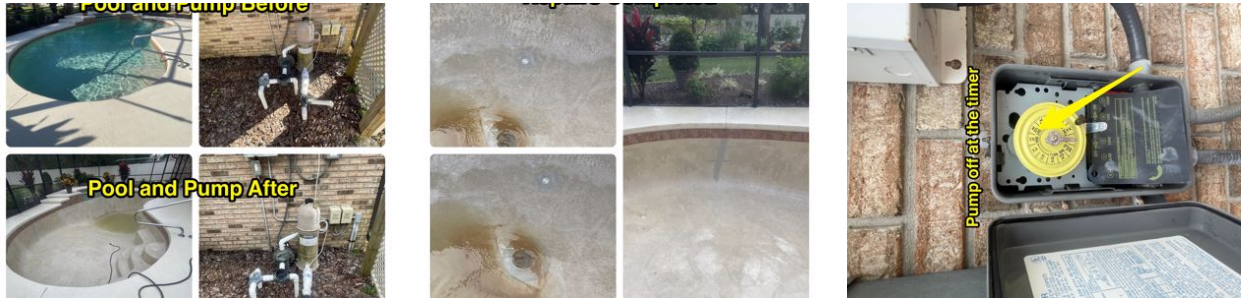
Friday, November 26, 2021 appointment

Repair completed. Water level is 1.5ft above bottom to match ground water and keep the pool safe. Pool can be filled immediately Pump is off at the timer Valves were readjusted to their original positions

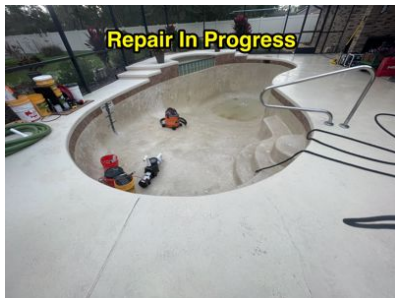
Wednesday, November 24, 2021 appointment

After a long battle with water tables today which required additional amount of material to be used to complete the main drain repair the specialists were unable to finish the repair today. The main drain has been re-plumbed and started to reseal into the shell of the pool but the specialists ran out of material before completion. This will require an extra appointment on Friday to complete the repair.
